Hydrological Problems of Fish Ponds in Urban Area of Sremska Mitrovica

**Dragan Dolinaj, Jovan Plavša,
Dragoslav Pavić**

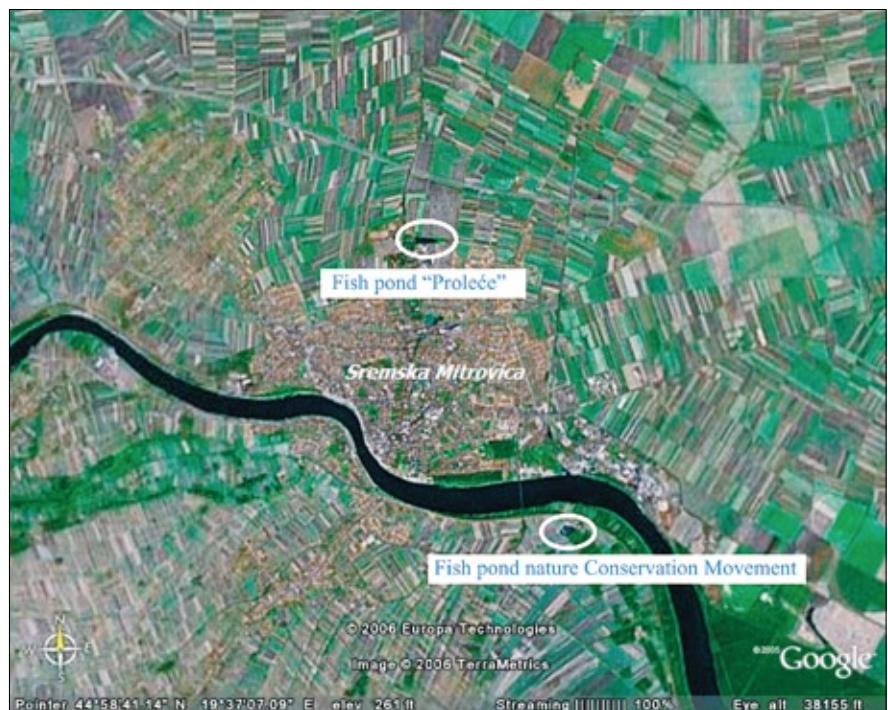
Appendix 1 Satellite picture of geographical position of Fish pond "Proleće" and Fish pond of nature Conservation Movement (Source: Google Earth)

Fish pond "Proleće" stretches on the west-east axis. The small pond is situated west of the large pond and its is a square in shape. The larger pond is in the east and its shape is elongated, wider in its western part, whereas its width decreases in its eastern part. The sides of the pond's basin are vertical, the shore being higher than the middle level of the pond for 80
