# Hydro-geological problems of Vranjaš accumulation (Vojvodina, Serbia)

Dragan Dolinaj<sup>1\*</sup>, Branko Ristanović<sup>2</sup>, Dragoslav Pavić<sup>1</sup>, Vladimir Stojanović<sup>1</sup>, Milana Pašić<sup>2</sup>

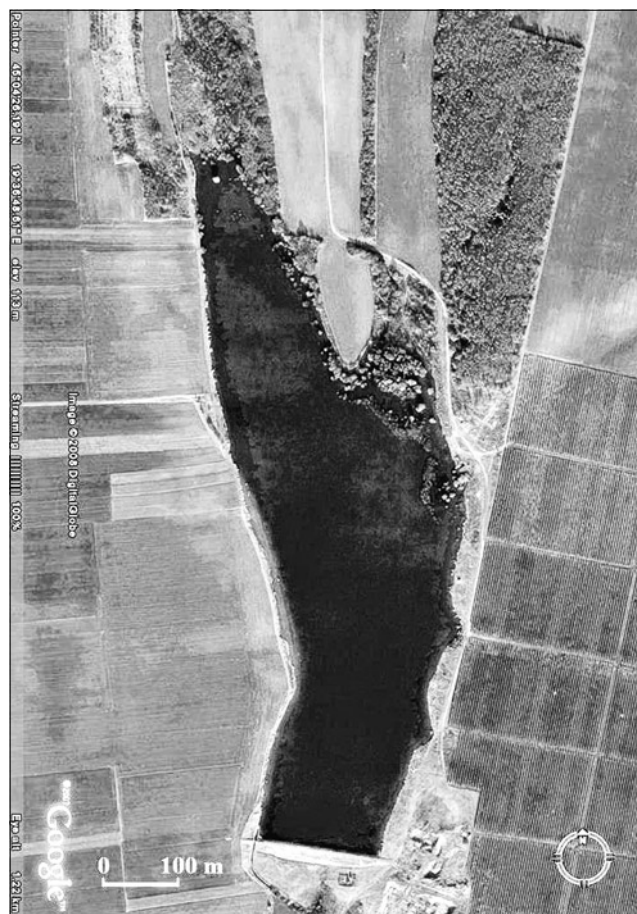
**Figure 3** Satellite photo of accumulation Vranjaš;  
Source: Google Earth

The lake has irregular shape and it stretches on the south-north axis. Lake basin is the widest in its central part (figure 5), it narrows at north (figure 4), whereas it slightly narrows in the south until it reaches the dimensions of the dam. Both east and west valley slopes slide gently into the lake basin. Only in its north part (north of wide bay) east bank is above the lake level, only 1.5-2 m above it (figure 4). At all other parts of the lake it is quite low and goes gently to the lake basin. Slopes are more noticeable at the east bank, very close to the dam. These banks are covered with grass, as well as the central parts of east and west coast, and reed can be noticed at some parts (figure 3, 5). At the north part of the east coast there are some trees and reed, whereas trees prevail at the north part of the east coast and reed can be noticed at the very banks of the lake (figure 3, 4).

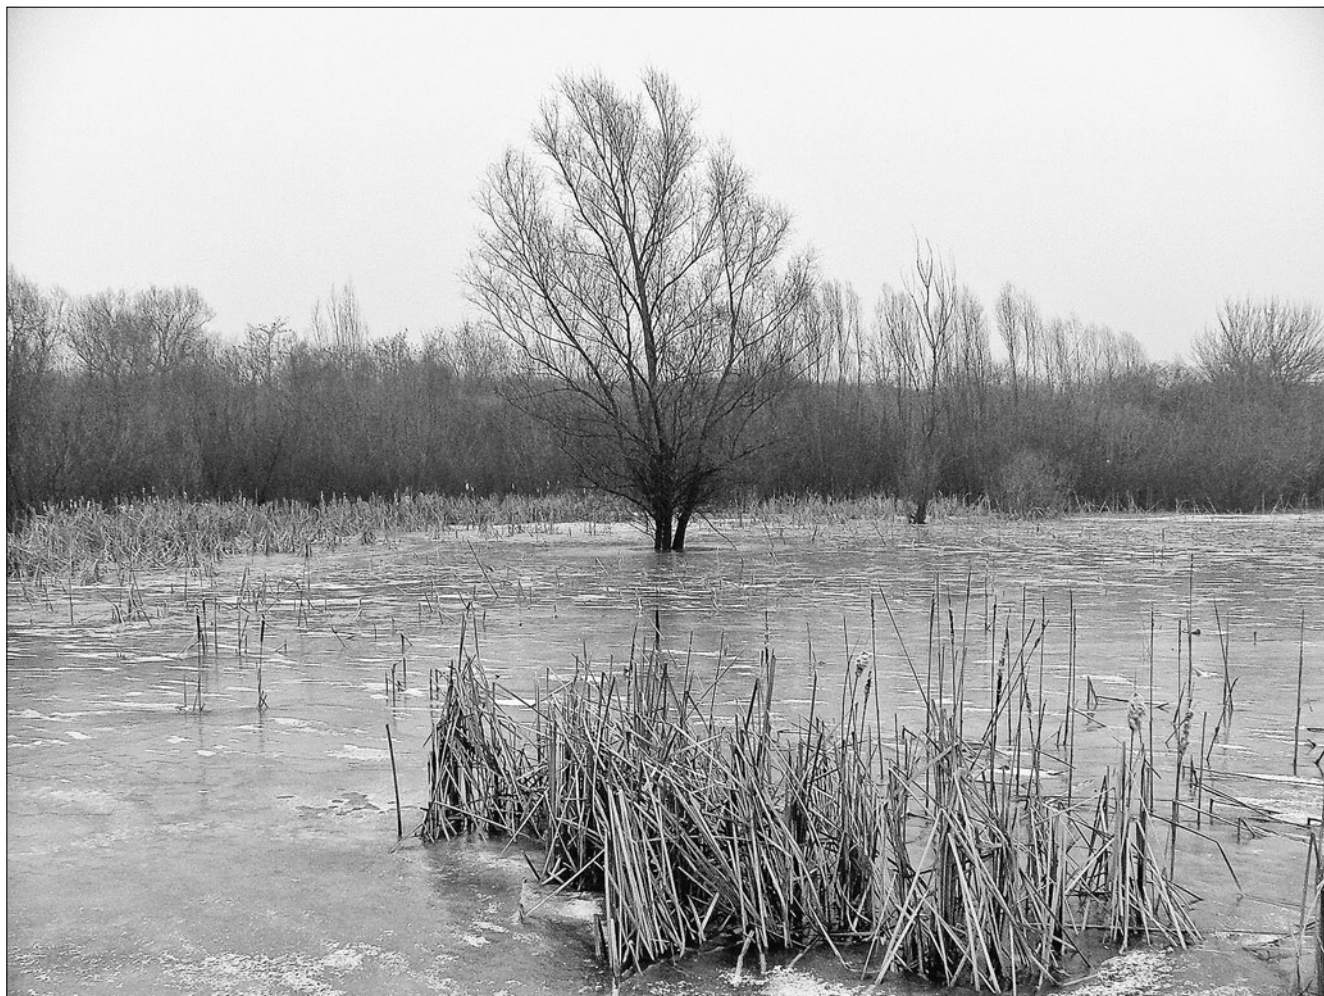
**Figure 4** North part of the lake, winter 2006; Photo: D. Dolinaj

Shallow north part of the lake is rich in aquatic vegetation, and the lake basin is rich in plants, trees and reed. The biggest problems of the lake are huge organic production at the north part of the lake (figure 4) and sludge deposits at its bottom, which are mostly of organic origin. At the north part of the lake, at its central part sludge layers are as thick as 90 and 130 cm. At the slopes of the basin these layers are around 70 cm.

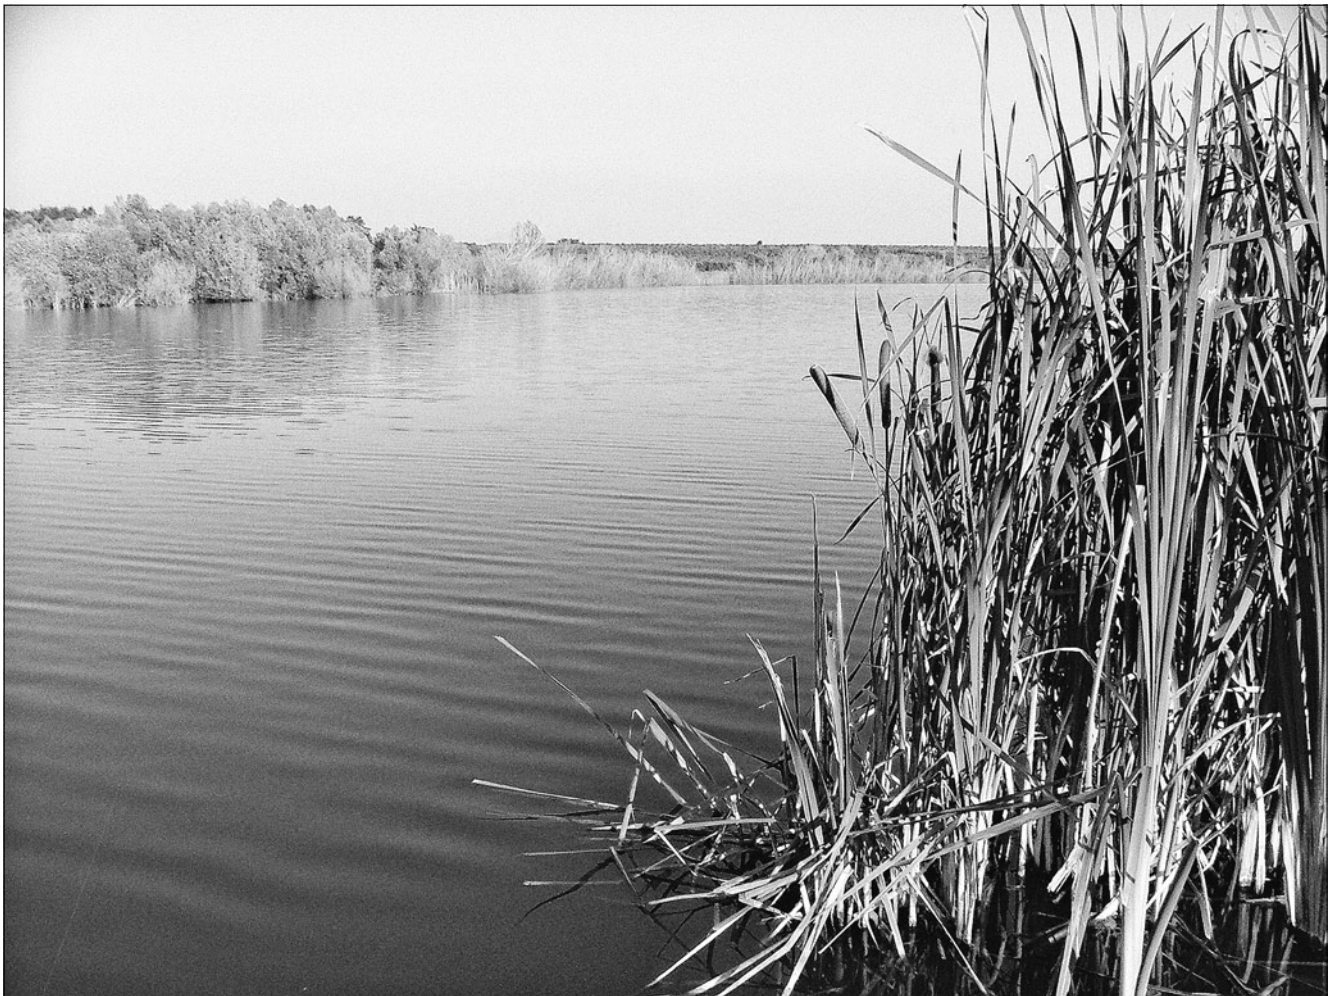
**Figure 5** Central part of the lake, summer 2005; Photo: D. Dolinaj
