# Effect of Seismic Activity on the Gravitational Processes Through the Example of the Butrointsi Rockfall, SW Bulgaria

This study investigates the relationship between rockfall and seismic activity. The article examines the development of the Butrointsi rockfall before the earthquake with a magnitude of Mw 5.6 on the Richter scale and the development which occurred as a result of the seismic activity. Comparing the rock blocks' size, their volume and the deposit's dynamics before and after the earthquake, the authors emphasize the role of the seismic factor for the activation of the rockfall process. Through the application of various methods (morphographics, morphometrics, sedimentologicals etc.) the authors make a complete profile of the deposits and calculate the amount of collapsed rocks caused by the earthquake.

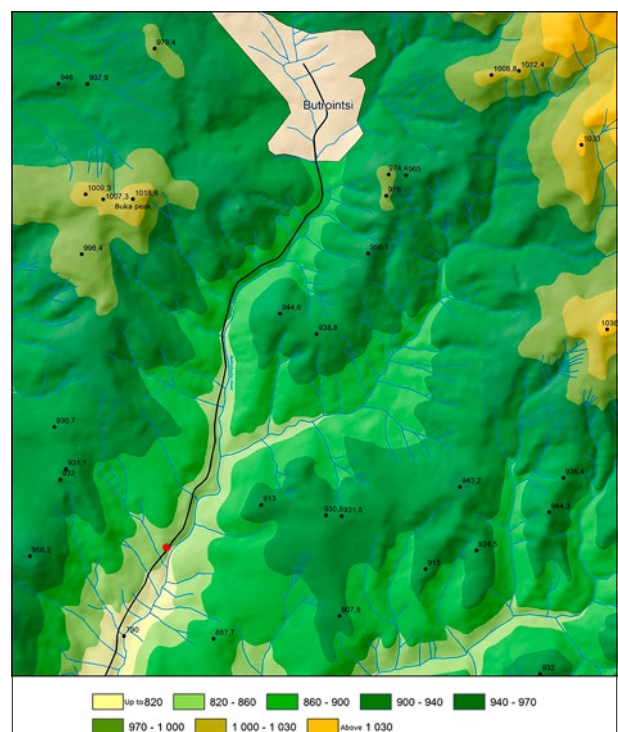
Figure 2. Digital Elevation Model and hypsometry

For the purposes of this study, a Digital Elevation Model (DEM) was created (Figure 2). The DEM contains elevation every 40 m. Altitude values in the re-

search area vary from 790 m in the midstream of the Butroinska River to 1085 m - northeast of the village Butrointsi. Exceedances of the relief reaches up to 295 m. The altitude decreases from the northeast to the southwest, and from the watershed to the carved valley of Butroinska River.

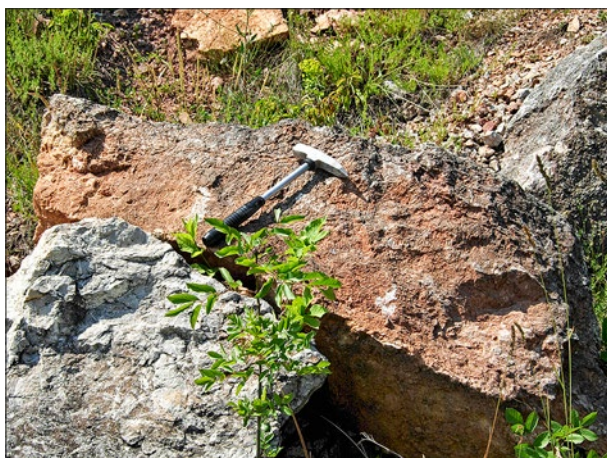
**Figure 3.** Limestone blocks, forming the Butroitsi rockfall

The rock involved in the rockfall process has cataclastic structure, with partial recrystallization of some of the main minerals. It consists of calcite, which comprises about 90% of the thin section. Quartz takes second place with about 6%. Plagioclase, clay minerals and hydroxides each have a share of about 2% (Figure 3).

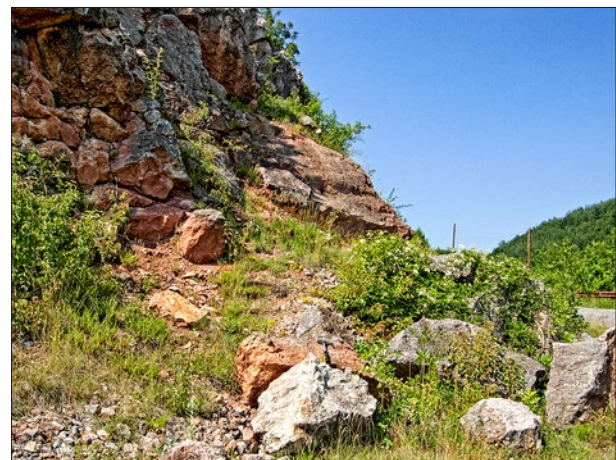
Figure 5. The Butrintsi rockfall at the beginning of the observation (2006)

The rockfall (Figure 5) is situated 2,2 km northeast of Filipovtsi and 1,8 km southwest of Butrintsi. As the rockfall is closer to Butrintsi, the authors offer, for more convenience, to be named after this village. It is located above the confluence of some streams of first order, which take their source from the Buka peak (1018, 6 m a.s.l.). They flow into the Butroinska river, which is a right tributary to the Yablanitsa river. The exposition is southeast. The altitude is 855 m. The exact location is 42° 50' 12" north, 22° 44' 24" east.

The scarp of the rockfall is about 6 m high. At its base there is a debris funnel with a thickness of about 3 m (Figure 5). The rocks are intensely fractured with

horizontal and subvertical cracks. The vertical crevices are secondary and less common. The scarp consists of jointed limestone and is approximately 4 m high. The accumulative part (the trail) is over 2 m thick and about 8 m long. The latter consists of two segments. One, which is relatively older, is formed by sand and gravel. On top of the fine grained underlayer larger rock blocks collapsed. Their maximum sizes vary as follows: 88/78/60; 70/50/30; 90/60/75; 102/80/70; 80/60/40; 75/55/50; 142/110/100; 12/5/4 (in cm).

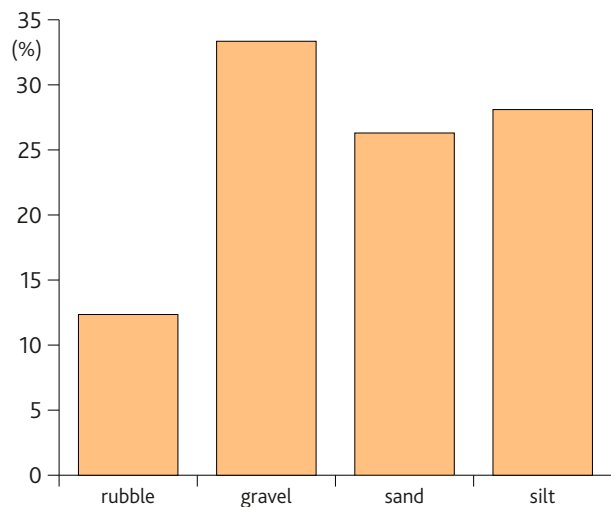
**Figure 6.** Results of granulometric analysis in histogram

The sample was picked up from the sandy underlayer of the rockfall. The fractions of the granulometric analysis are shown on Table 2 and on the histogram (Figure 6).

The following conclusions can be made based on the results. The filler is clay-sandy. The deposits contain mixed fractions. Sand, gravel and clay have an almost equal share. The large pieces (blocks and gravel) make up to 46% of the sample and the small ones (clay and sand) up to 54%. The gravel's share in is the smallest. Although this is not typical of a rockfall process, it can be explained by the fact that the sample has been taken from the lower part of the rockfall, where more sand is present. After they are detached from the massif, the rock fragments are subject to continuous exogenous influence, which results in further disintegration.

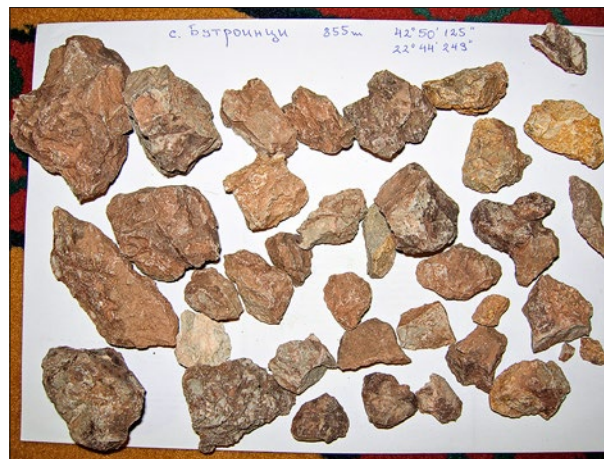
**Figure 7.** Rock samples for morphoscopic analysis

The morphoscopic analysis has been carried out by examining 30 rock pieces (Figure 7). All of the pieces have similar petrographic composition – limestone, although some pieces have an outer calcite crust and orange coloration. The age of the limestone is Upper Cretaceous (Zagorchev and al., 1991). The results of the morphoscopic analysis are presented in Table 3.

The conclusions, obtained through the morphoscopic analysis are as follows: The average dimensions of the rock fragments on axes “a”, “b” and “c” are respectively: 40, 30 and 22 mm. The maximum dimensions reach up to 90, 63 and 41 mm. These results from

jointing in the upper part of the massif, where between 10 and 15 joints per linear meter are observed. The roundness of all fragments is 0 (according to the scale of Serebryanyi, 1980). This is characteristic of the rockfall process. It indicates the fact that gravity is the main driving force and the transport is short. The ma-

majority of the fragments are spherical (47%) and 27% are cylindrical. The form indicates that the mechanism of transport is saltation.

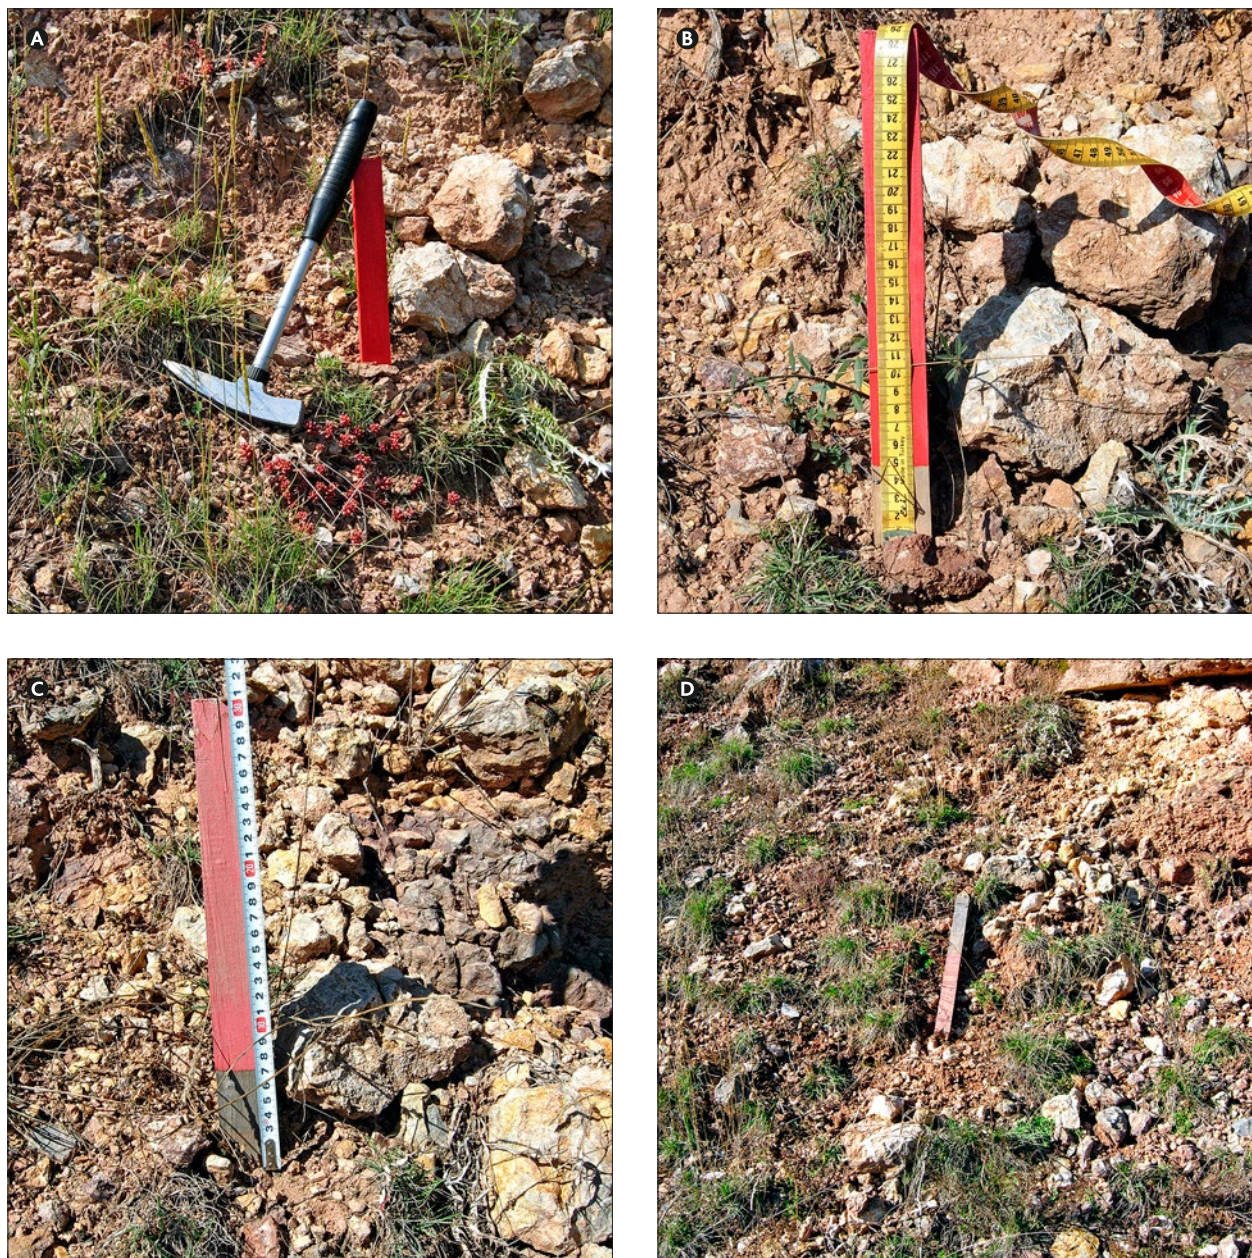
In early 2006, during the first visit, we placed a small wooden stake in the bottom (accumulative) part, with the hope of capturing rockfall at close and tracking the dynamics of the deposits. The marked stake is regularly observed for the entire 4-year period (Figure 8). The following conclusions can be drawn from the obtained data: The maximum denudation is 23.8 cm, where the stake is completely bare, upturned and moved at a 1-metre distance down the slope; the minimum denudation is 2 cm. The average rate of denudation is 5.95 cm per year. Early spring (April, May) is the period, when the most active slope denudation occurs. The highest rates of denudation and the largest collapsed rock fragments have been registered during this period. Late autumn (October, November) proves as the second period of high denudation activity. The denudation activity is at its lowest in the summer and in the winter.

**Figure 8.** Regular reports on marked stake for 4- years observation period:  
A) time sequence - 07.07.2006 B) 29.10.2006 - 4,6 cm denudation C) 16.09.2007 - 6,6 cm denudation D) 29.11.2009 - 22 cm denudation - the rod is inverted and moved 1 m over the slope

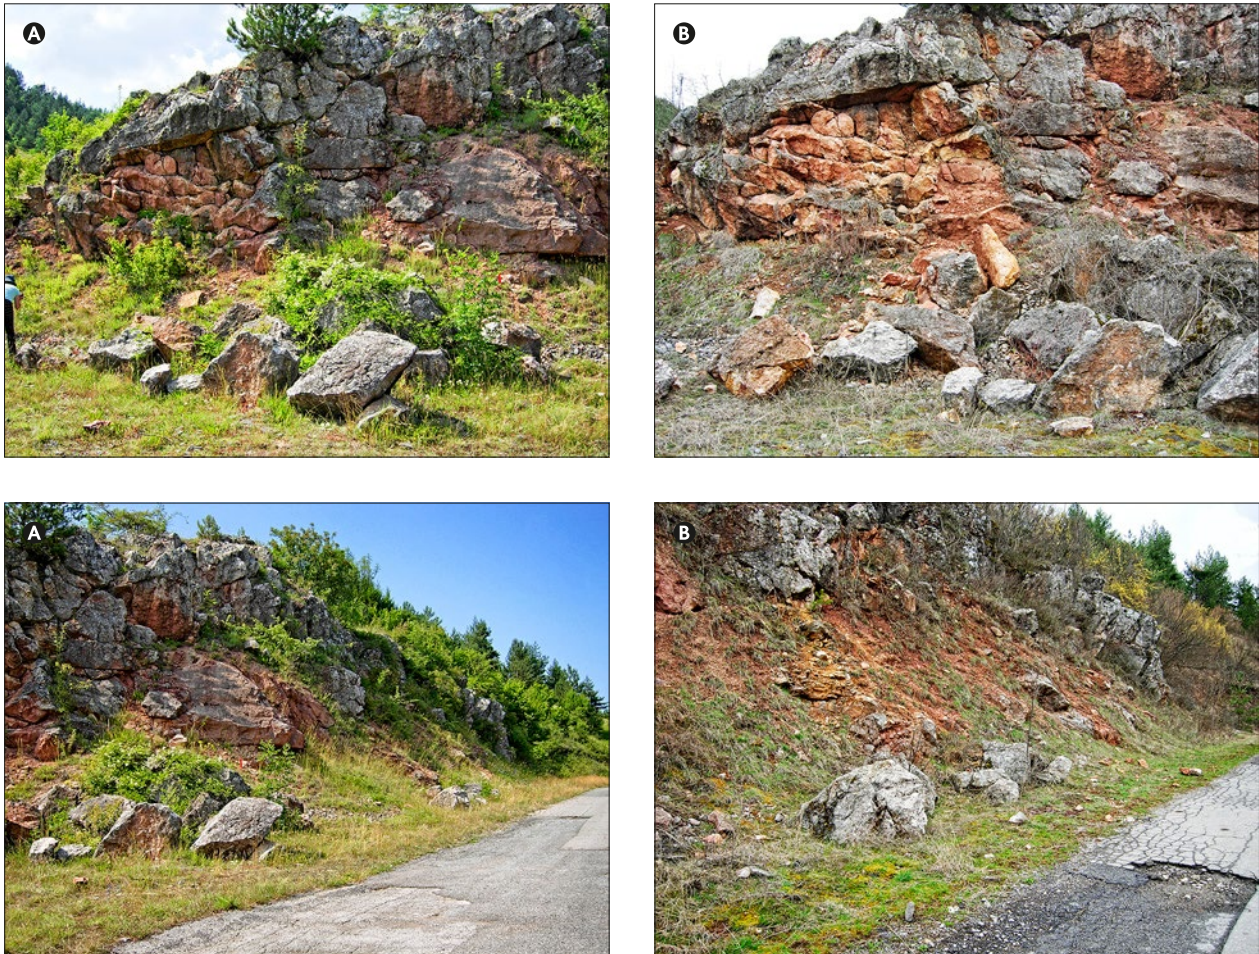
The development of the rockfall in the beginning and in the end of the 4-years' period of observation is presented on Figure 9. To the left is the rockfall as of 07.07.2006 and to the right – as of 05.04.2010. The pictures provide clear evidence that the rockfall process has been very dynamic. The results of the marked stake also confirm this conclusion. The maximum size of the newly fallen rock fragments varies as follows: 19/18/7, 19/13/8, 19/12/7, 15/11/7, 13/10/6,5, 42/32/13, 35/21/20, 23/19/16, 36/17/15, 17/13/7 (in cm). Driven by the power of their own weight, the largest chunks are transported at the greatest distance, thus reaching the

road, while the smaller material is deposited on the slope over the previously fallen rocks. The big number of newly collapsed large blocks near the road indicates that the process entails risks and makes reinforcement measures obligatory.

Figure 9. Dynamics of rockfall for 4-years of observations. A – on 07.07.2006 B – on 05.04.2010

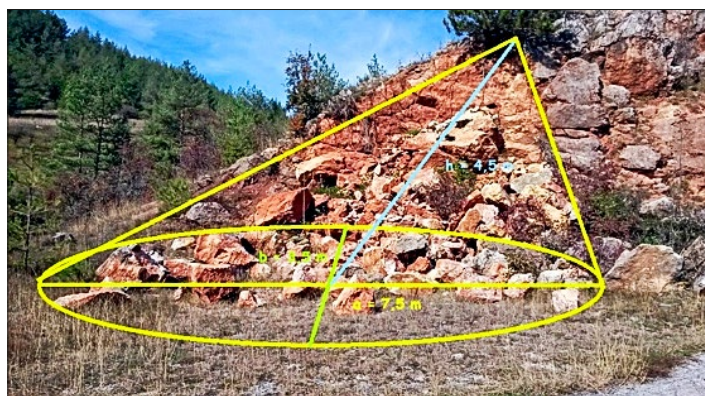
Figure 10. Calculation the volume of the follen mass

The amount of the collapsed mass as a consequence of the earthquake of Mw 5.6 in Pernik (22.05.2012) is calculated using mathematical formulas for the calculation of the area of an ellipse and the volume of a cone. The rockfall is assumed to be an about 4.5 m high cone whose peak is at the base of the pine tree (on top of

the cone). The base of the rockfall is assumed to be an ellipse with a major axis of 7,5 m and a minor axis of 3,5 m (Figure 10). The Figure clearly shows that the so formed cone is not completely full of rock mass. There is an empty space of about 35% which is subtracted from the calculated volume. Thus the calculated volume of collapsed rock mass as a result of the earthquake amounts to approximately 22 m<sup>3</sup>.

$$30,91 - 35\% = 21.64 \text{ m}^3$$

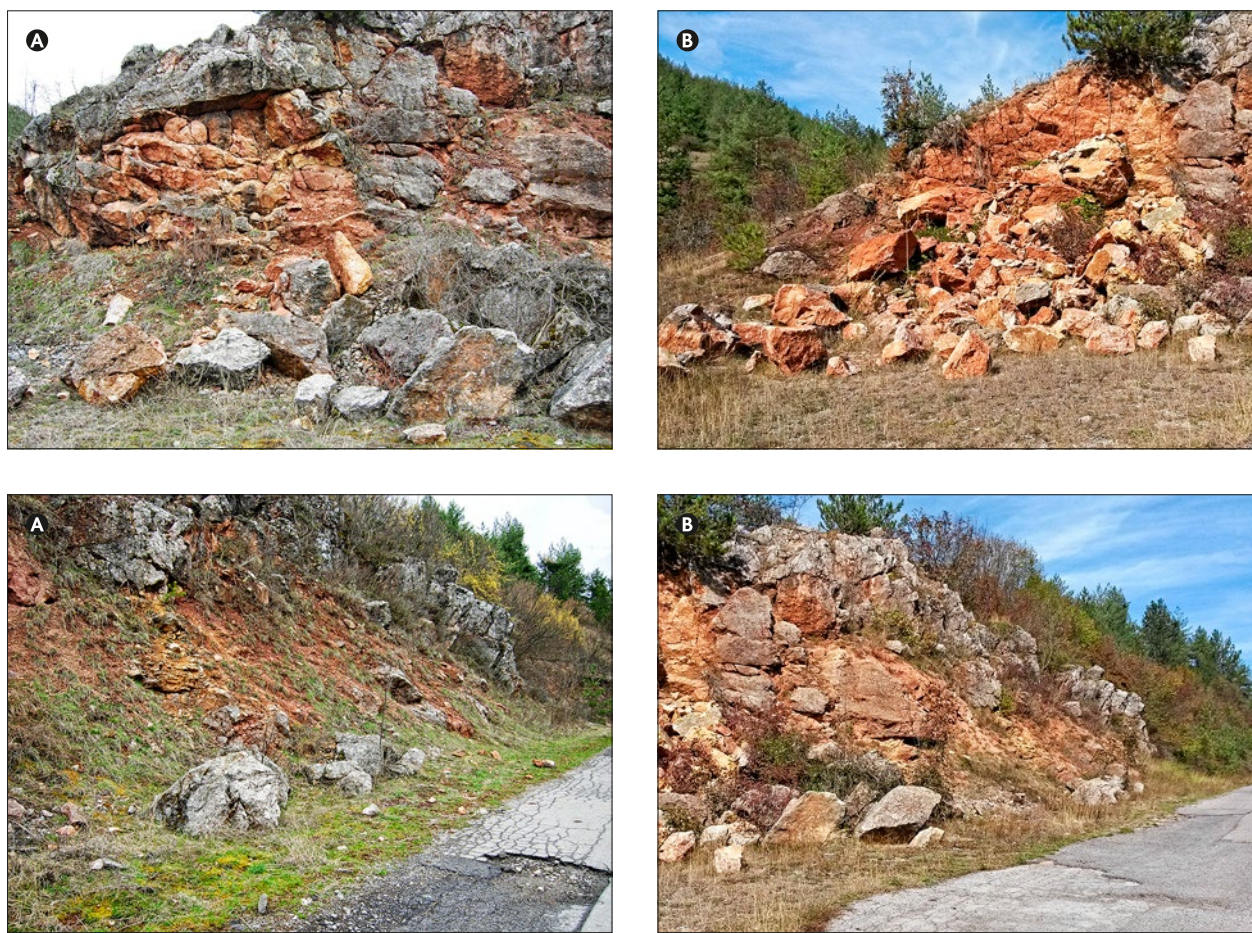
The dynamics of rockfall due to the seismic factor is shown on Figure 11. The dimension of the larg-

est fallen blocks on axes a, b and c in cm are as follows: 101/63/50, 106/85/48, 108/71/53, 105/69/43, 96/48/42, 87/56/49, 73/43/26, 78/52/28, 68/45/21, 84/49/38. The number of blocks has grown, too. While the number of larger collapsed blocks (about 100 cm on axis a) varies between 5 and 8 during the four-year period prior to the earthquake, their number has grown several times after the earthquake. After the falling and the accumulation of rock mass it can be clearly seen that the roots of the plants grow in the crevices and reach further than

Figure 11. The dynamics of rockfall in a result of seismic activity. A – before the earthquake B – after the earthquake

The comparison of the size of the rock blocks before and after the earthquake indicates that their dimensions are quite similar. The same holds true in respect of the way of accumulation. Most of the largest blocks are deposited at the greatest distance from the slope, while the smaller ones are deposited in the vicinity. Therefore, it can be concluded that the size of the collapsed blocks is determined by the crevices caused by weathering in horizontal and subvertical direction which bear no relation to the earthquake. In the crevices the rocks cohesion is damaged and the power of gravity along with the rainfall or the earthquake has brought about the falldown. There is a marked contrast in the volume of collapsed rock mass before and after the earthquake. Before the latter, over a period of 4 years, single large collapsed blocks have been registered, while after the earthquake there are tens of large fallen blocks. The total volume of the fallen rock mass amounts to 22 m<sup>3</sup>.
