Use of historical sources in a study of the 1895 floods on the Danube River and its tributaries

Marián Melo^A, Pavla Pekárová^B, Pavol Miklánek^B, Katarína Melová^C, Cytia Dujsíková^D

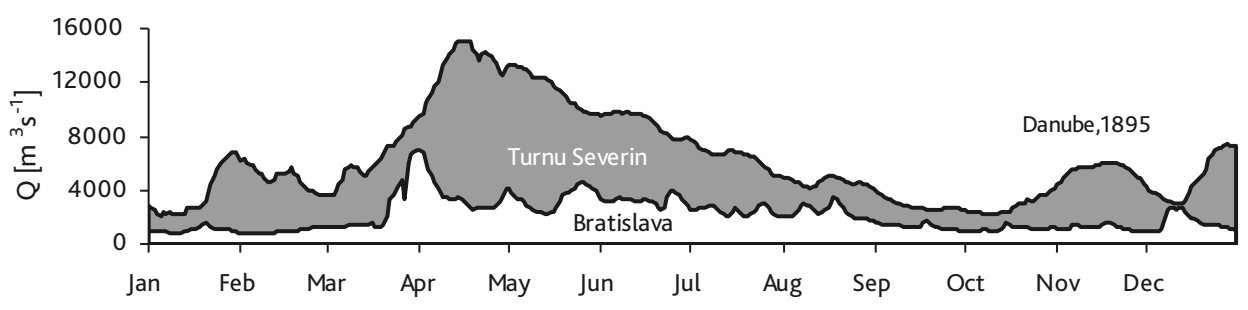
Figure 4. Mean daily discharge hydrographs from the Danube gauging stations of Bratislava and Turnu Severin/Orsova in 1895.

We used the mean daily discharge data (as well as the maximum annual discharge) from the database of the "Flood regime of rivers in the Danube basin" project from two stations: Danube: Bratislava and Danube: Turnu-Severin (Orsova). In Figure 4 there is the mean daily discharge in the selected stations in 1895. In 1895,

the flood water at the Bratislava station culminated on 31 March 1895 with a discharge of $6979 \text{ m}^3 \text{ s}^{-1}$. At Orsova, the flood wave in 1895 culminated on 14-18 April (about 16 days later than at Bratislava) with a discharge of $15200 \text{ m}^3 \text{ s}^{-1}$.

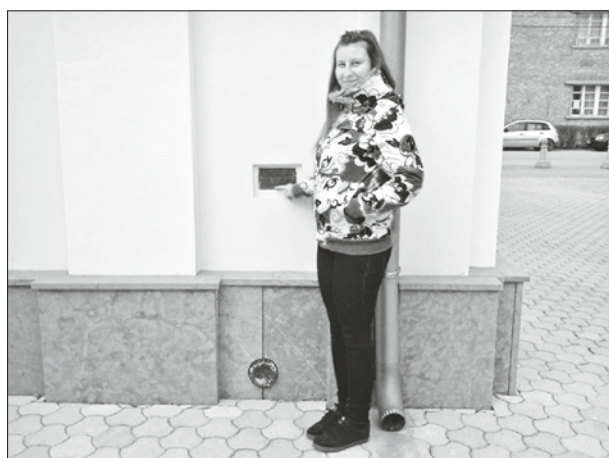
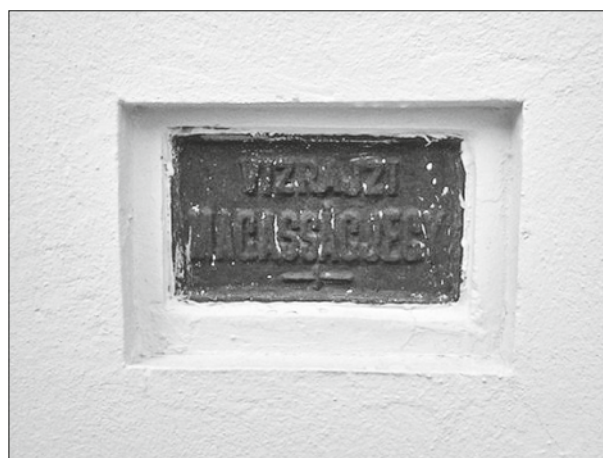
Figure 5. The 1895 flood mark in Komárom, St. Stephen's church (photo by C.Dujsíková, 2013)

After the Danube flood of 1895, six flood marks remained on historical buildings in towns located near the river (three in Slovakia: Bratislava, Komárno and Iža; three in Hungary: Komárom (Figure 5), Szőny (Figure 6) and Szigetmonostor). In all of these cases the maximum flood water level is expressed by marks delineated on churches. They contain the same brief descriptions of the flooding events in Hungarian: "VIZRAJZI MAGASSÁGJEGY 1895" ("hydrograph-

ic level mark 1895”) and indicate the peak flood water level. From these marks it is possible to imagine the actual Danube water level's elevation in 1895. We also found one flood mark in 1895 from the Tisza River (Szeged in Hungary).

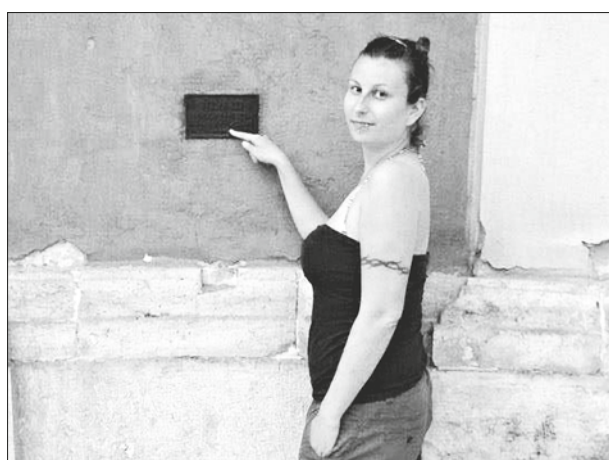
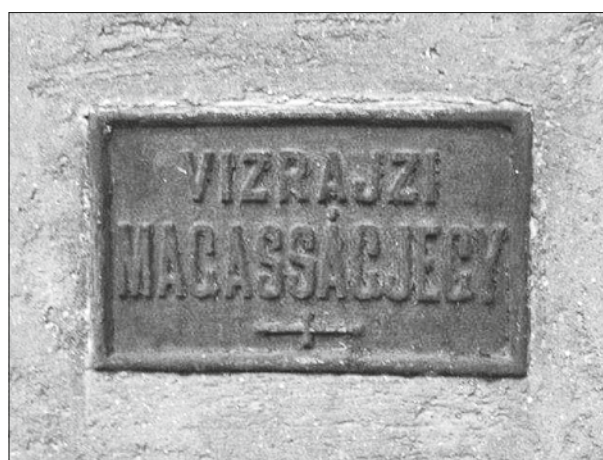
Figure 6. The 1895 flood mark in Szőny on a Roman Catholic church (photo by C.Dujsíková, 2013)

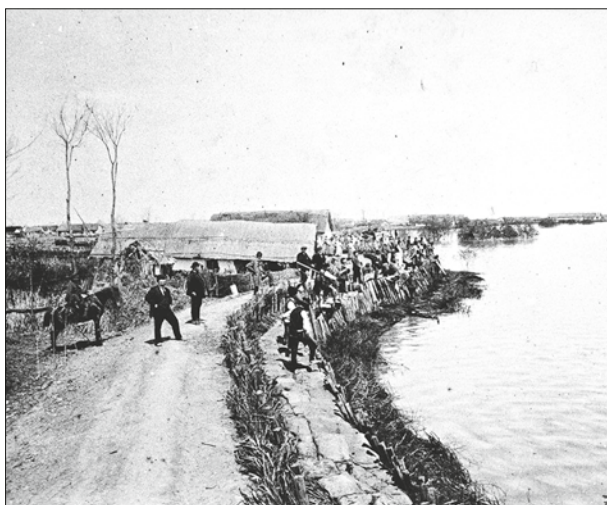
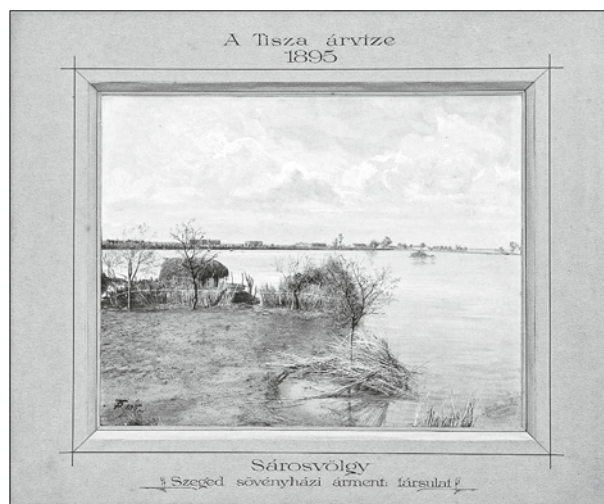
Figure 9. The Tisza flood (April 1895)

(the photos on the left and right are taken from the archives of the Danube Museum in Esztergom, Hungary)

Some mentions of the flooding in 1895 are recorded in the yearbook of meteorological observations of 1895 (JCME, 1898) (e.g., Přerov on the Bečva River in the Czech Republic) and in a book “Study of selected natural extremes and their impacts in Moravia and Silesia” (Brázdil, et al., 2007) (e.g., the Dyje and Svatka rivers in the Czech Republic). Contemporary photos suitably illustrate the flooding events. During the flood of 1895, water overflowed several inundation areas of the Tisza River (Figure 9), and the streets of Orsova were underwater (Figure 10).

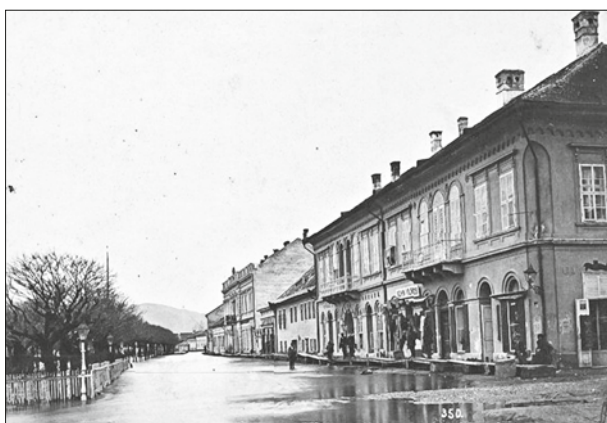
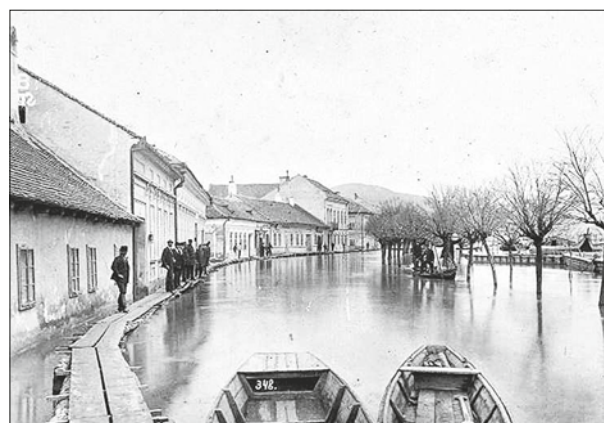
Figure 10. The Danube flood at Orsova (April 1895)

(photos on the left and right are taken from reference: <http://orsova.xhost.ro/>).
